HISTORIC AMERICAN BUILDINGS SURVEY
INVENTORY

2. NAME *Orrin Thompson Mansion*

DATE OR PERIOD *1832*
STYLE *Greek Revival*
ARCHITECT
BUILDER *Orrin Thompson*

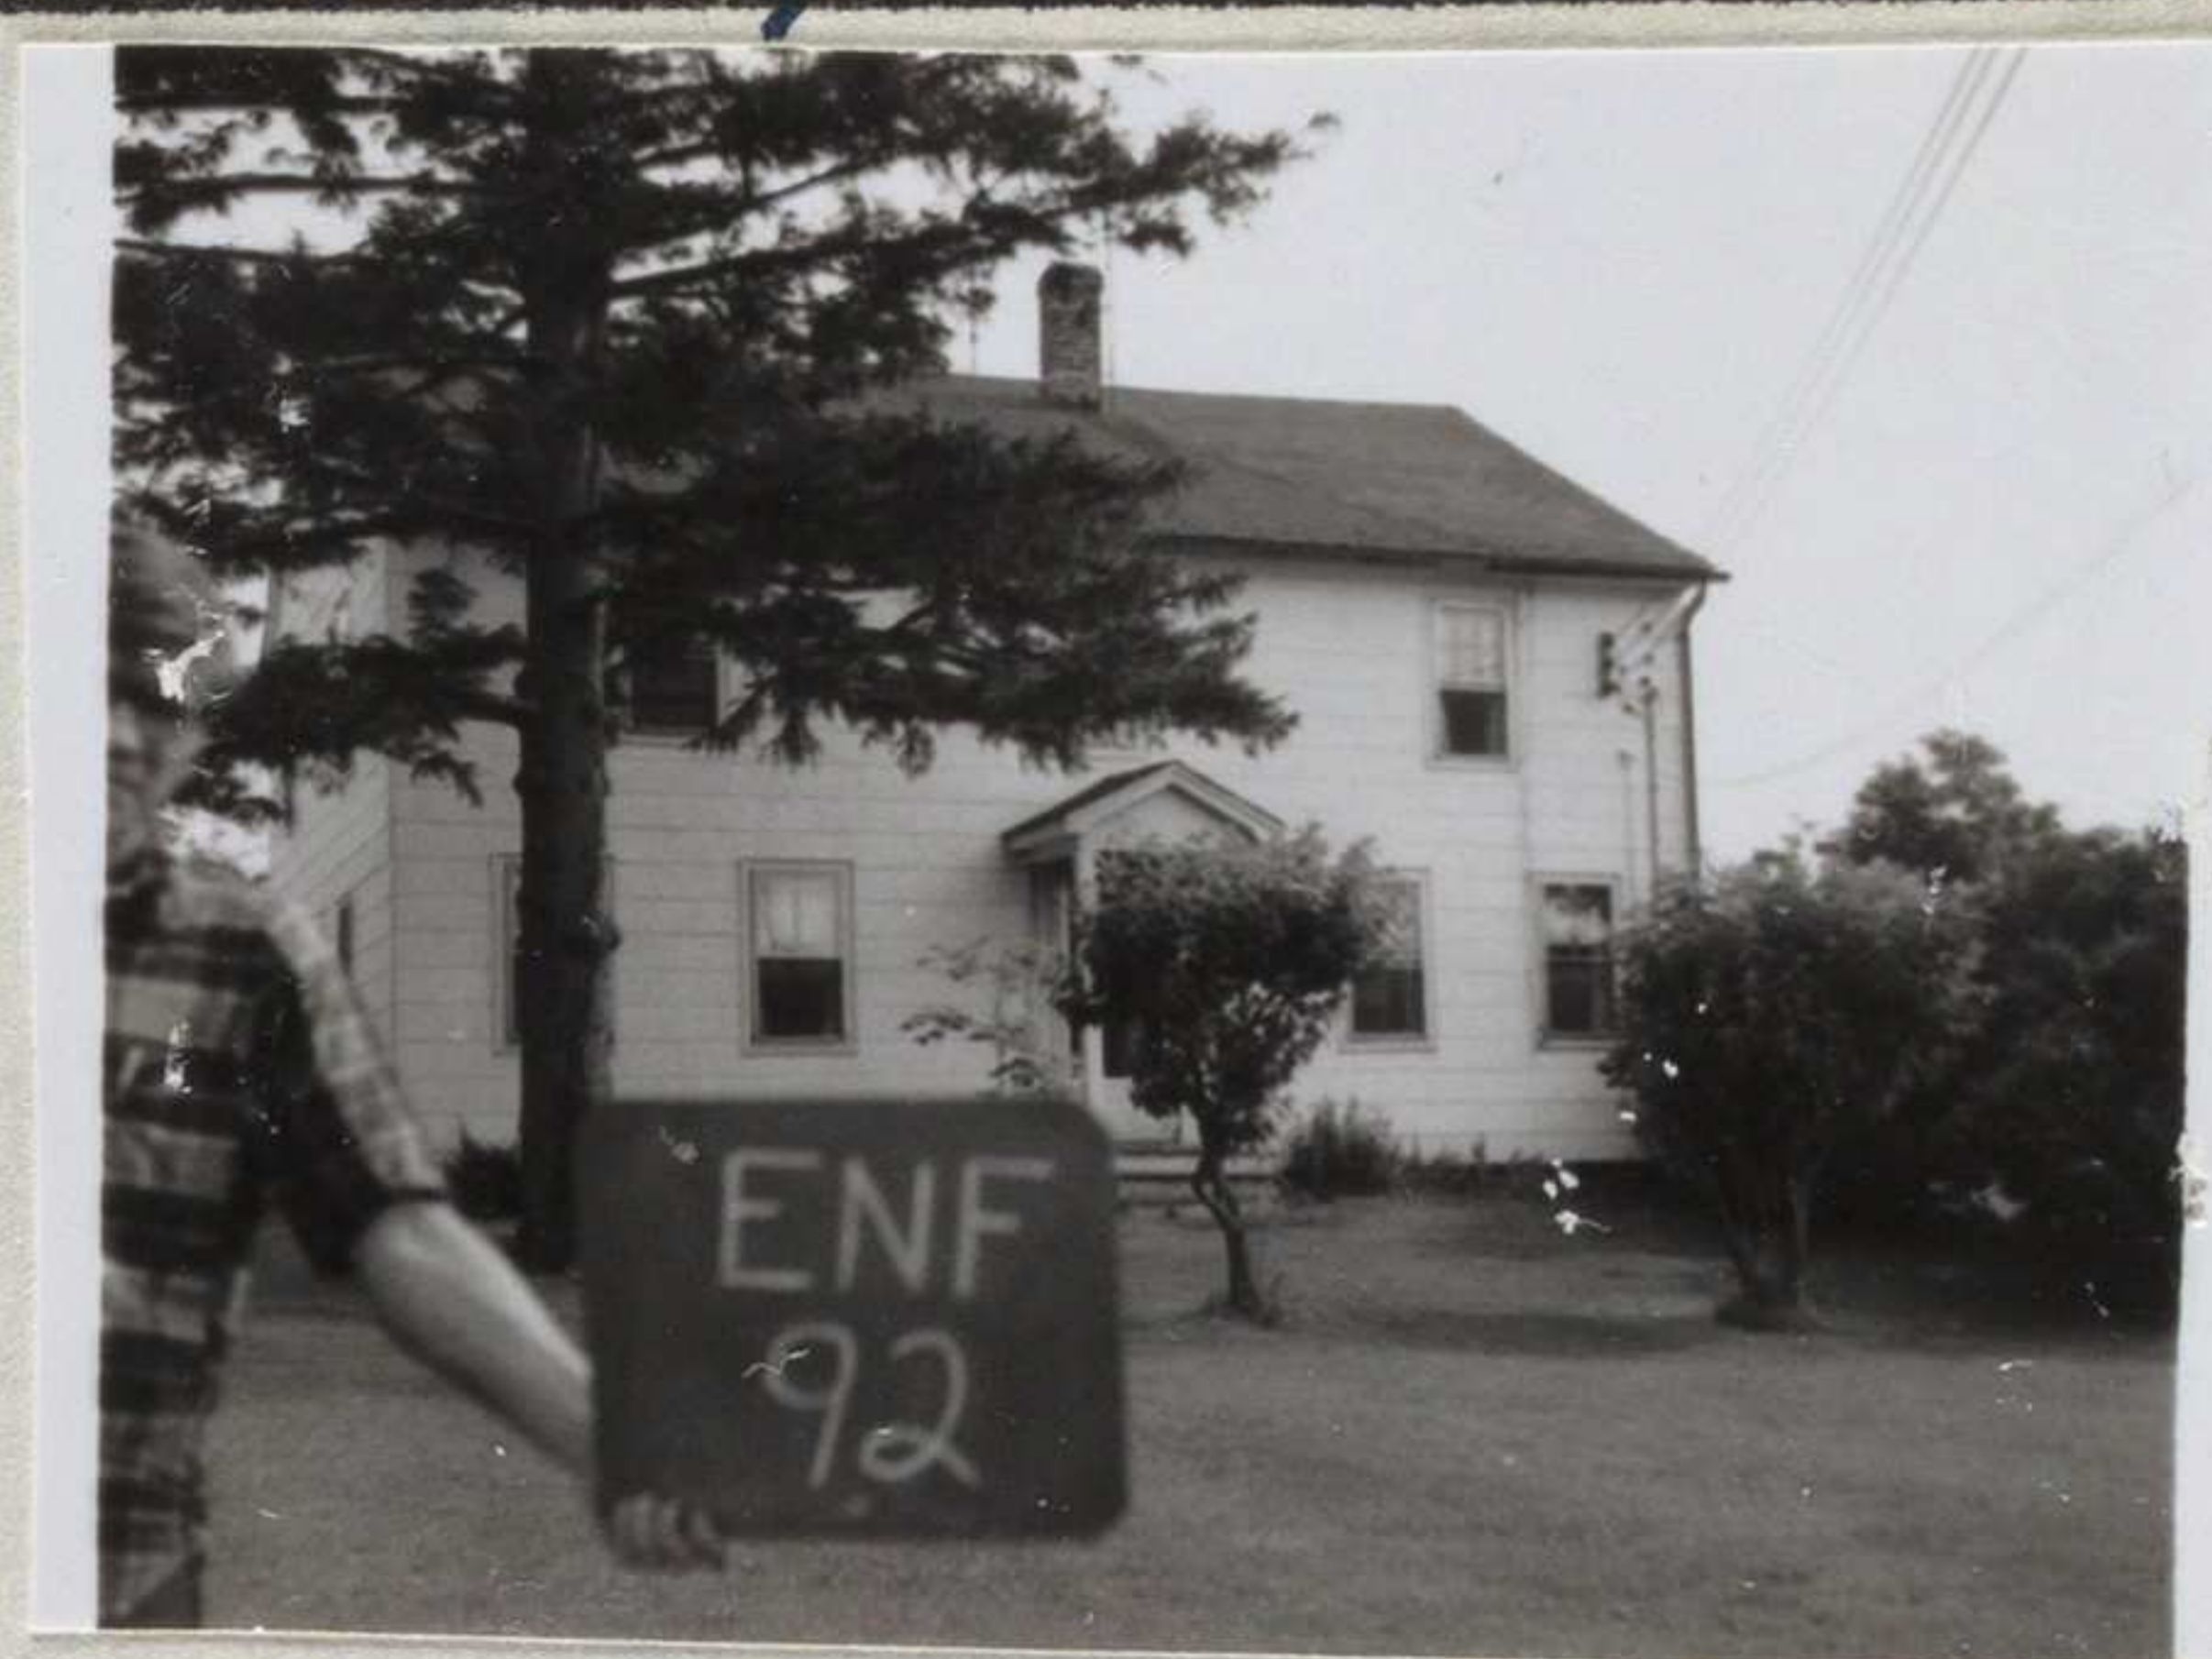
7. PHOTOGRAPH *Enf 92*

This house has been moved three times. At one time it was opposite the Ephraim Pease house on Enfield Street. It is built on a brownstone foundation and has five bays. The roof is shallow pitched, the central chimney new. Those windows that remain unaltered are 6/6's. The doorway molding and transom and door are original. The transom leaded.

5. PHYSICAL CONDITION OF STRUCTURE

Endangered ?

Interior *poor* Exterior *poor*

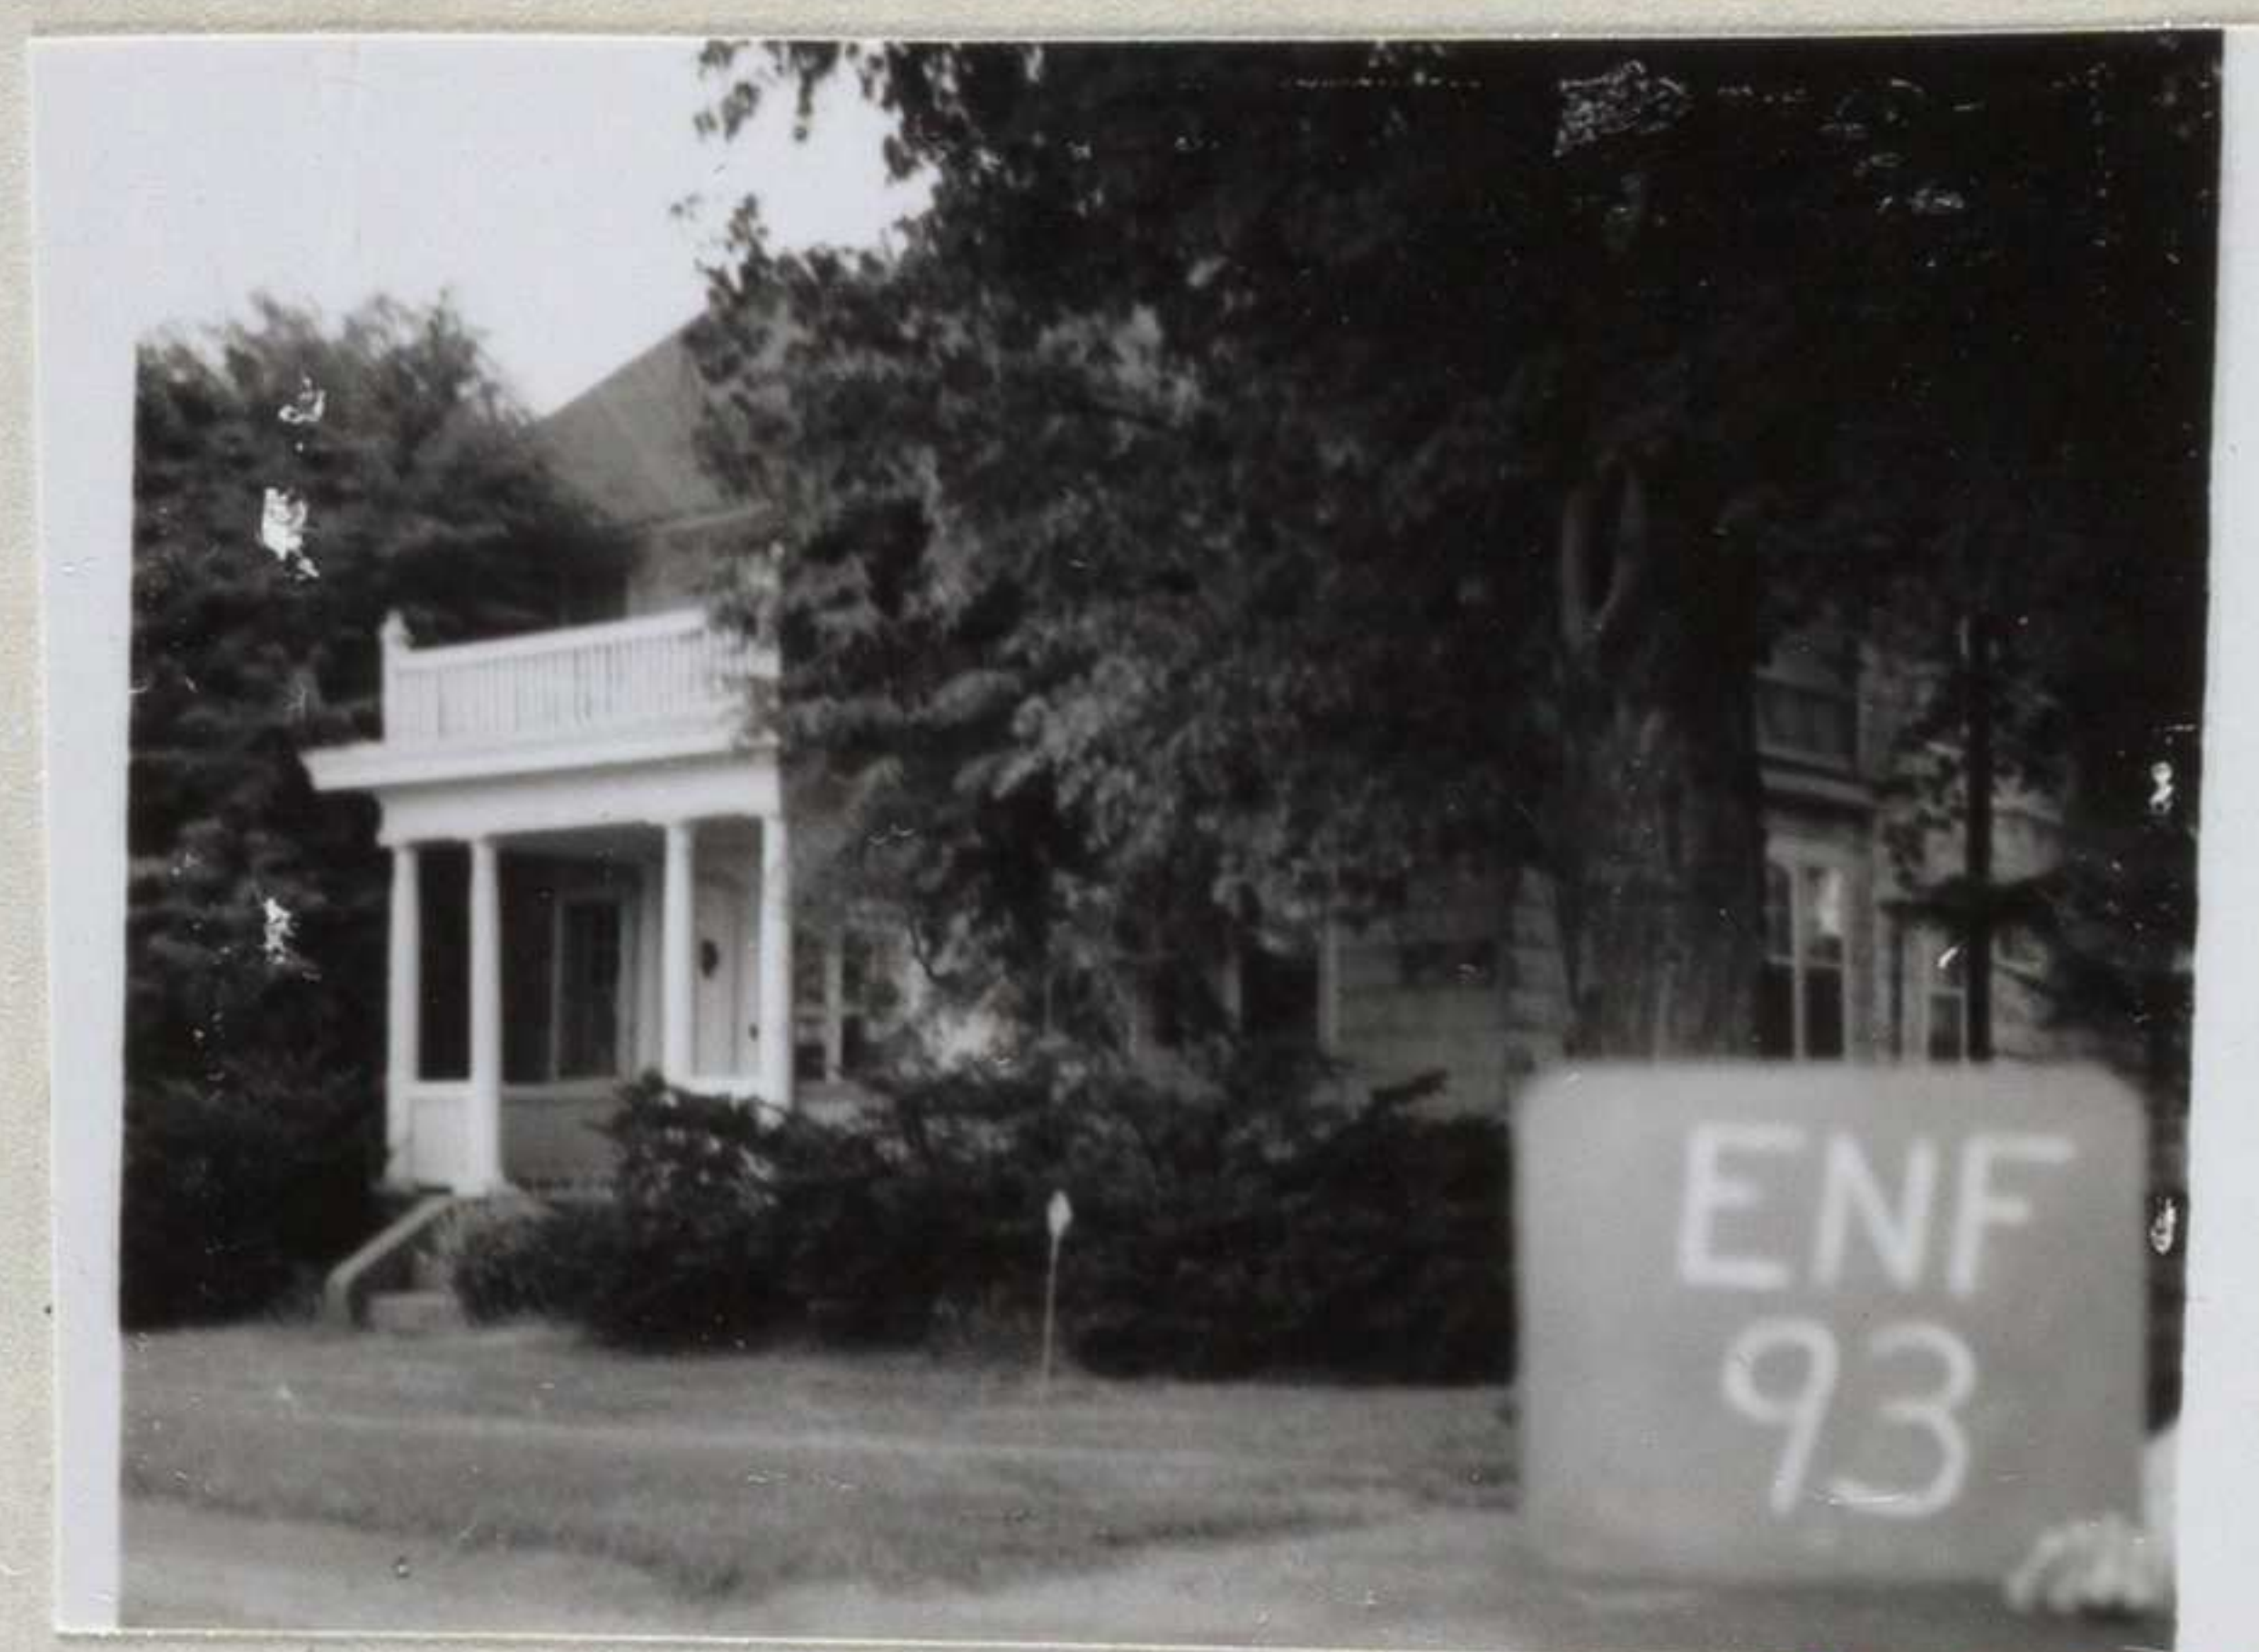
7. PHOTOGRAPH *ENF 93*

Built on a brownstone foundation this five bay facade house has a large steep roof with a large (non original) chimney. The windows are 6/6's which may be replacements. The doorway is very wide but the doors are new, as is the portico and the south wing. The rear wing may be quite old.

5. PHYSICAL CONDITION OF STRUCTURE

Endangered *No* Interior *Poor* Exterior *Poor*

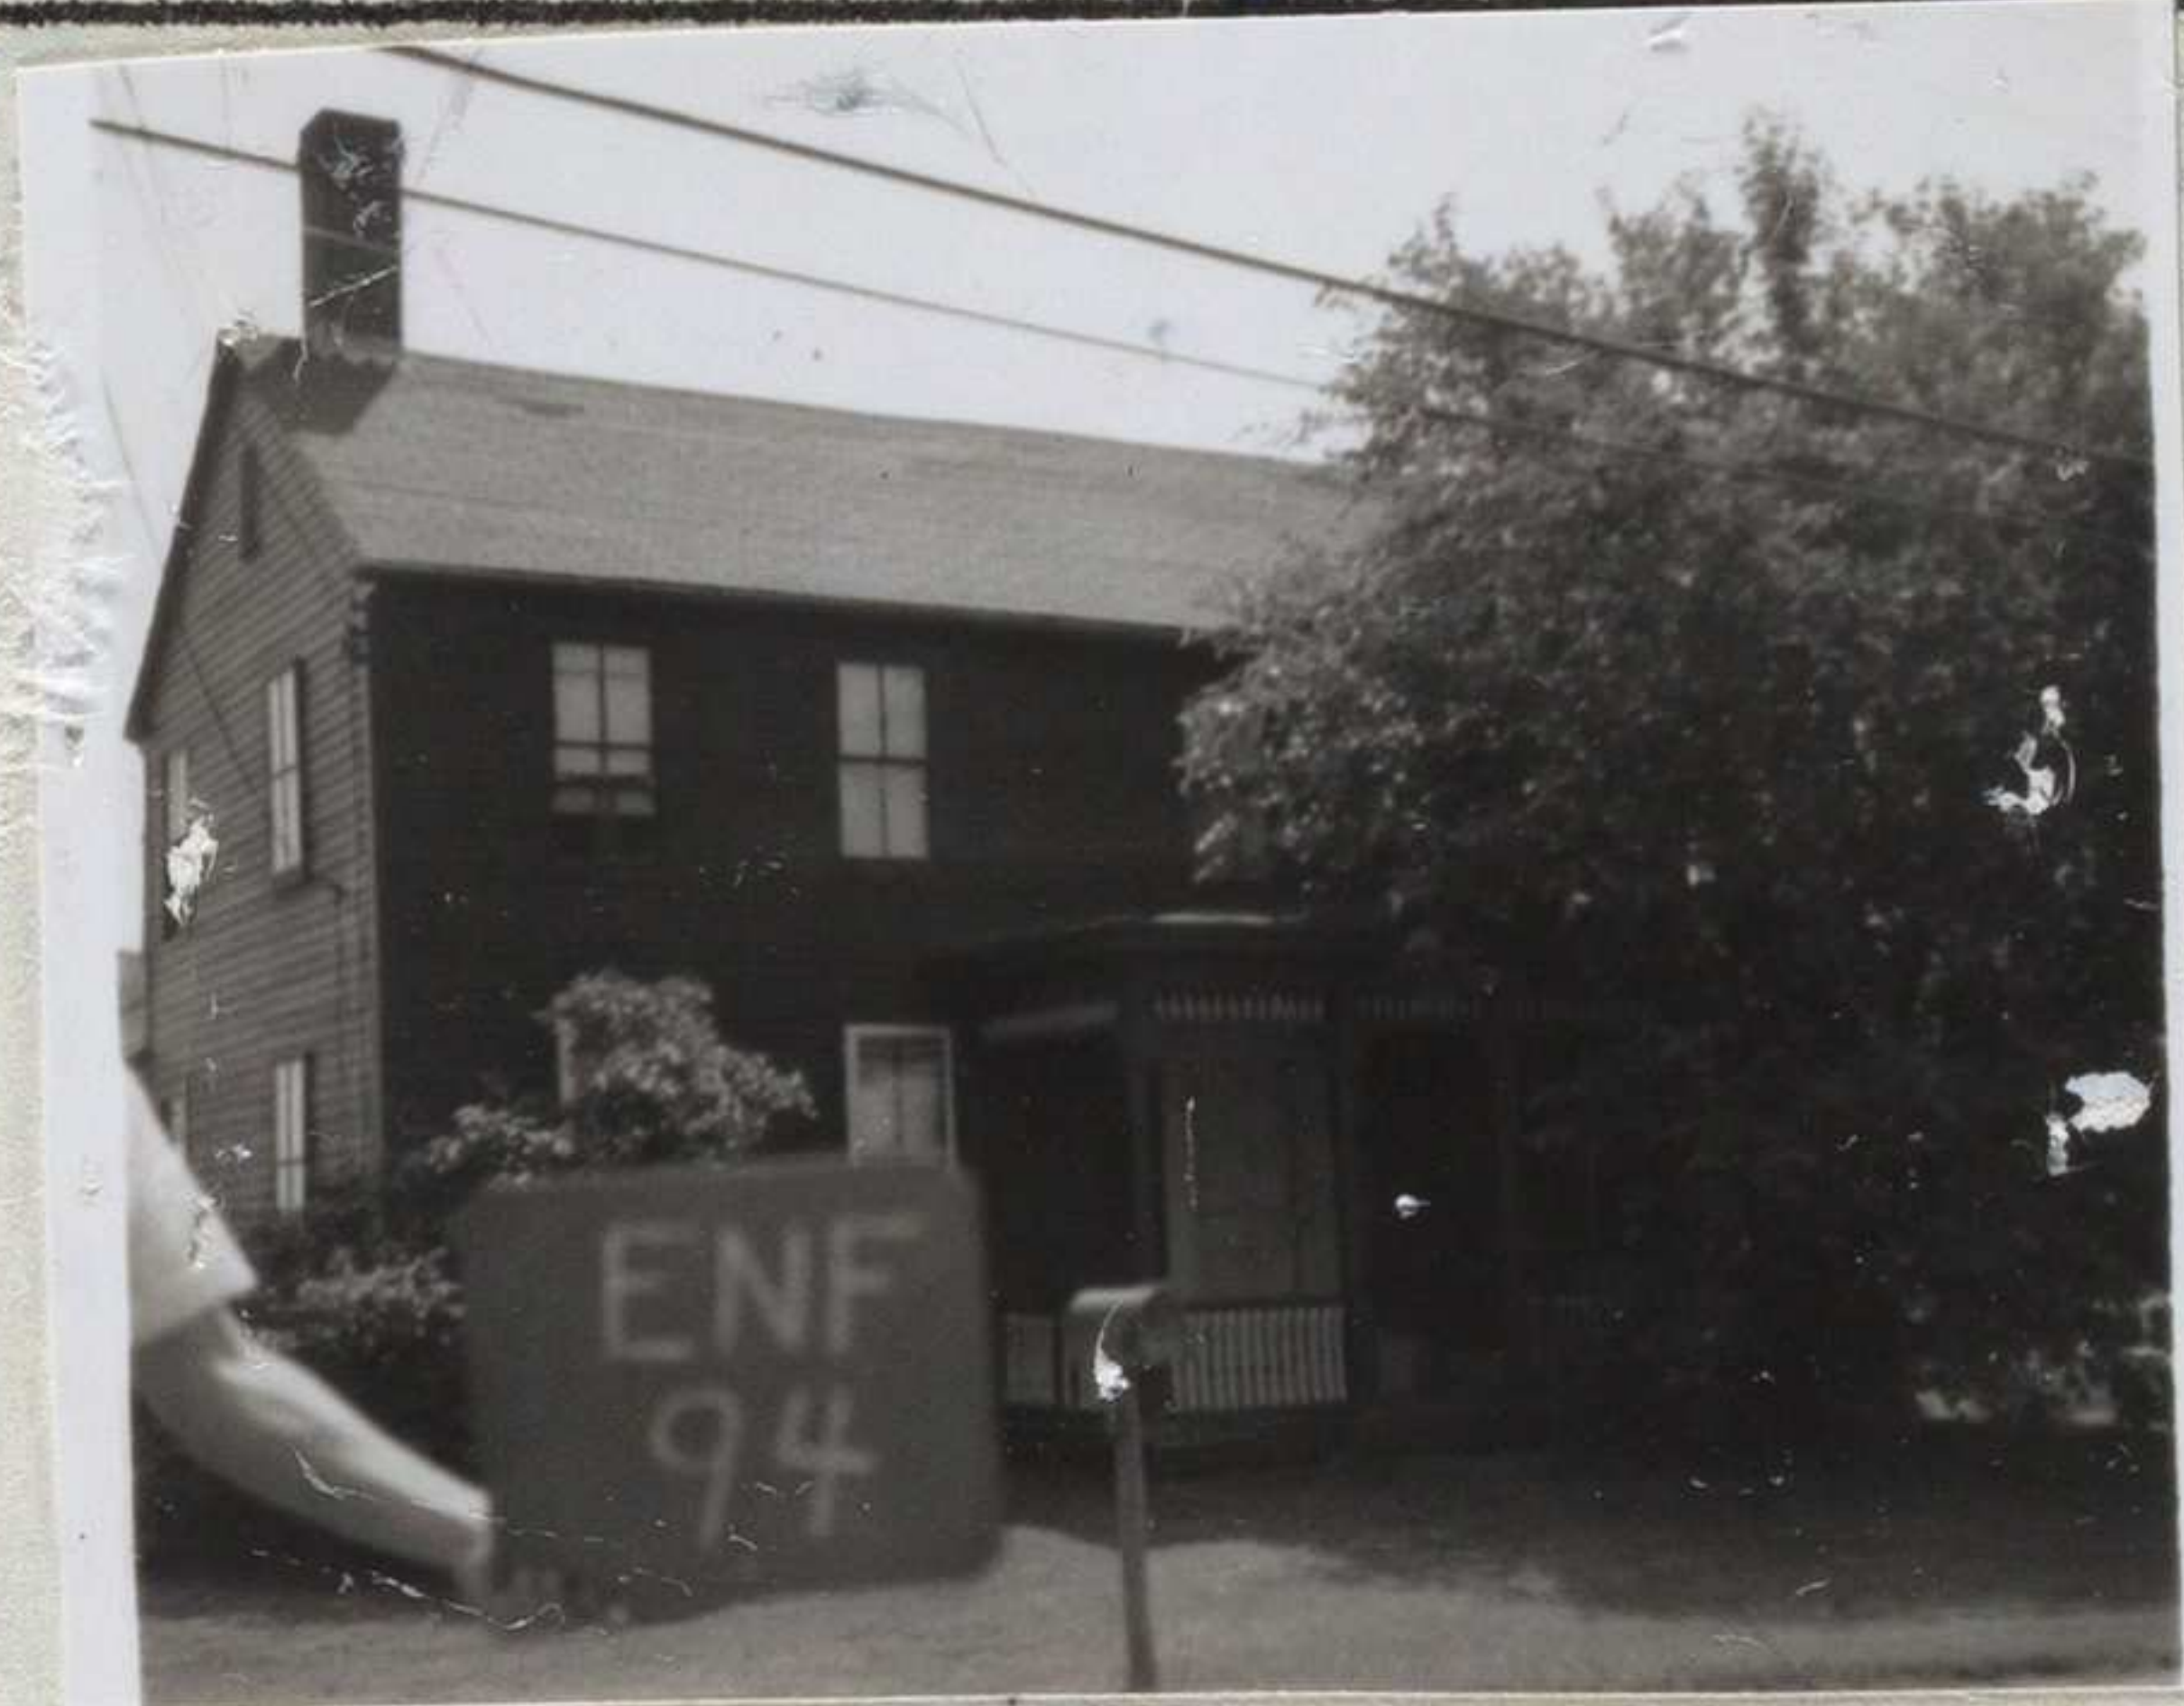
7. PHOTOGRAPH <i>Enf 94</i>

4. NOTABLE FEATURES, HISTORICAL SIGNIFICANCE AND DESCRIPTION <i>Built on a brownstone foundation this five bay house must surely have been built for a farmer farmer of small means. The roof is of shallow pitch with two end chimneys. The depth of the house is slight with a long ell to the rear. The windows are non-original and behind the 1870's porch is a Greek revival door with fine dentiling replacing the original of which there is only a small part of the molding remaining</i>	OPEN TO PUBLIC <i>No</i>
5. PHYSICAL CONDITION OF STRUCTURE Endangered <i>No</i> Interior <i>poor</i> Exterior <i>poor</i>

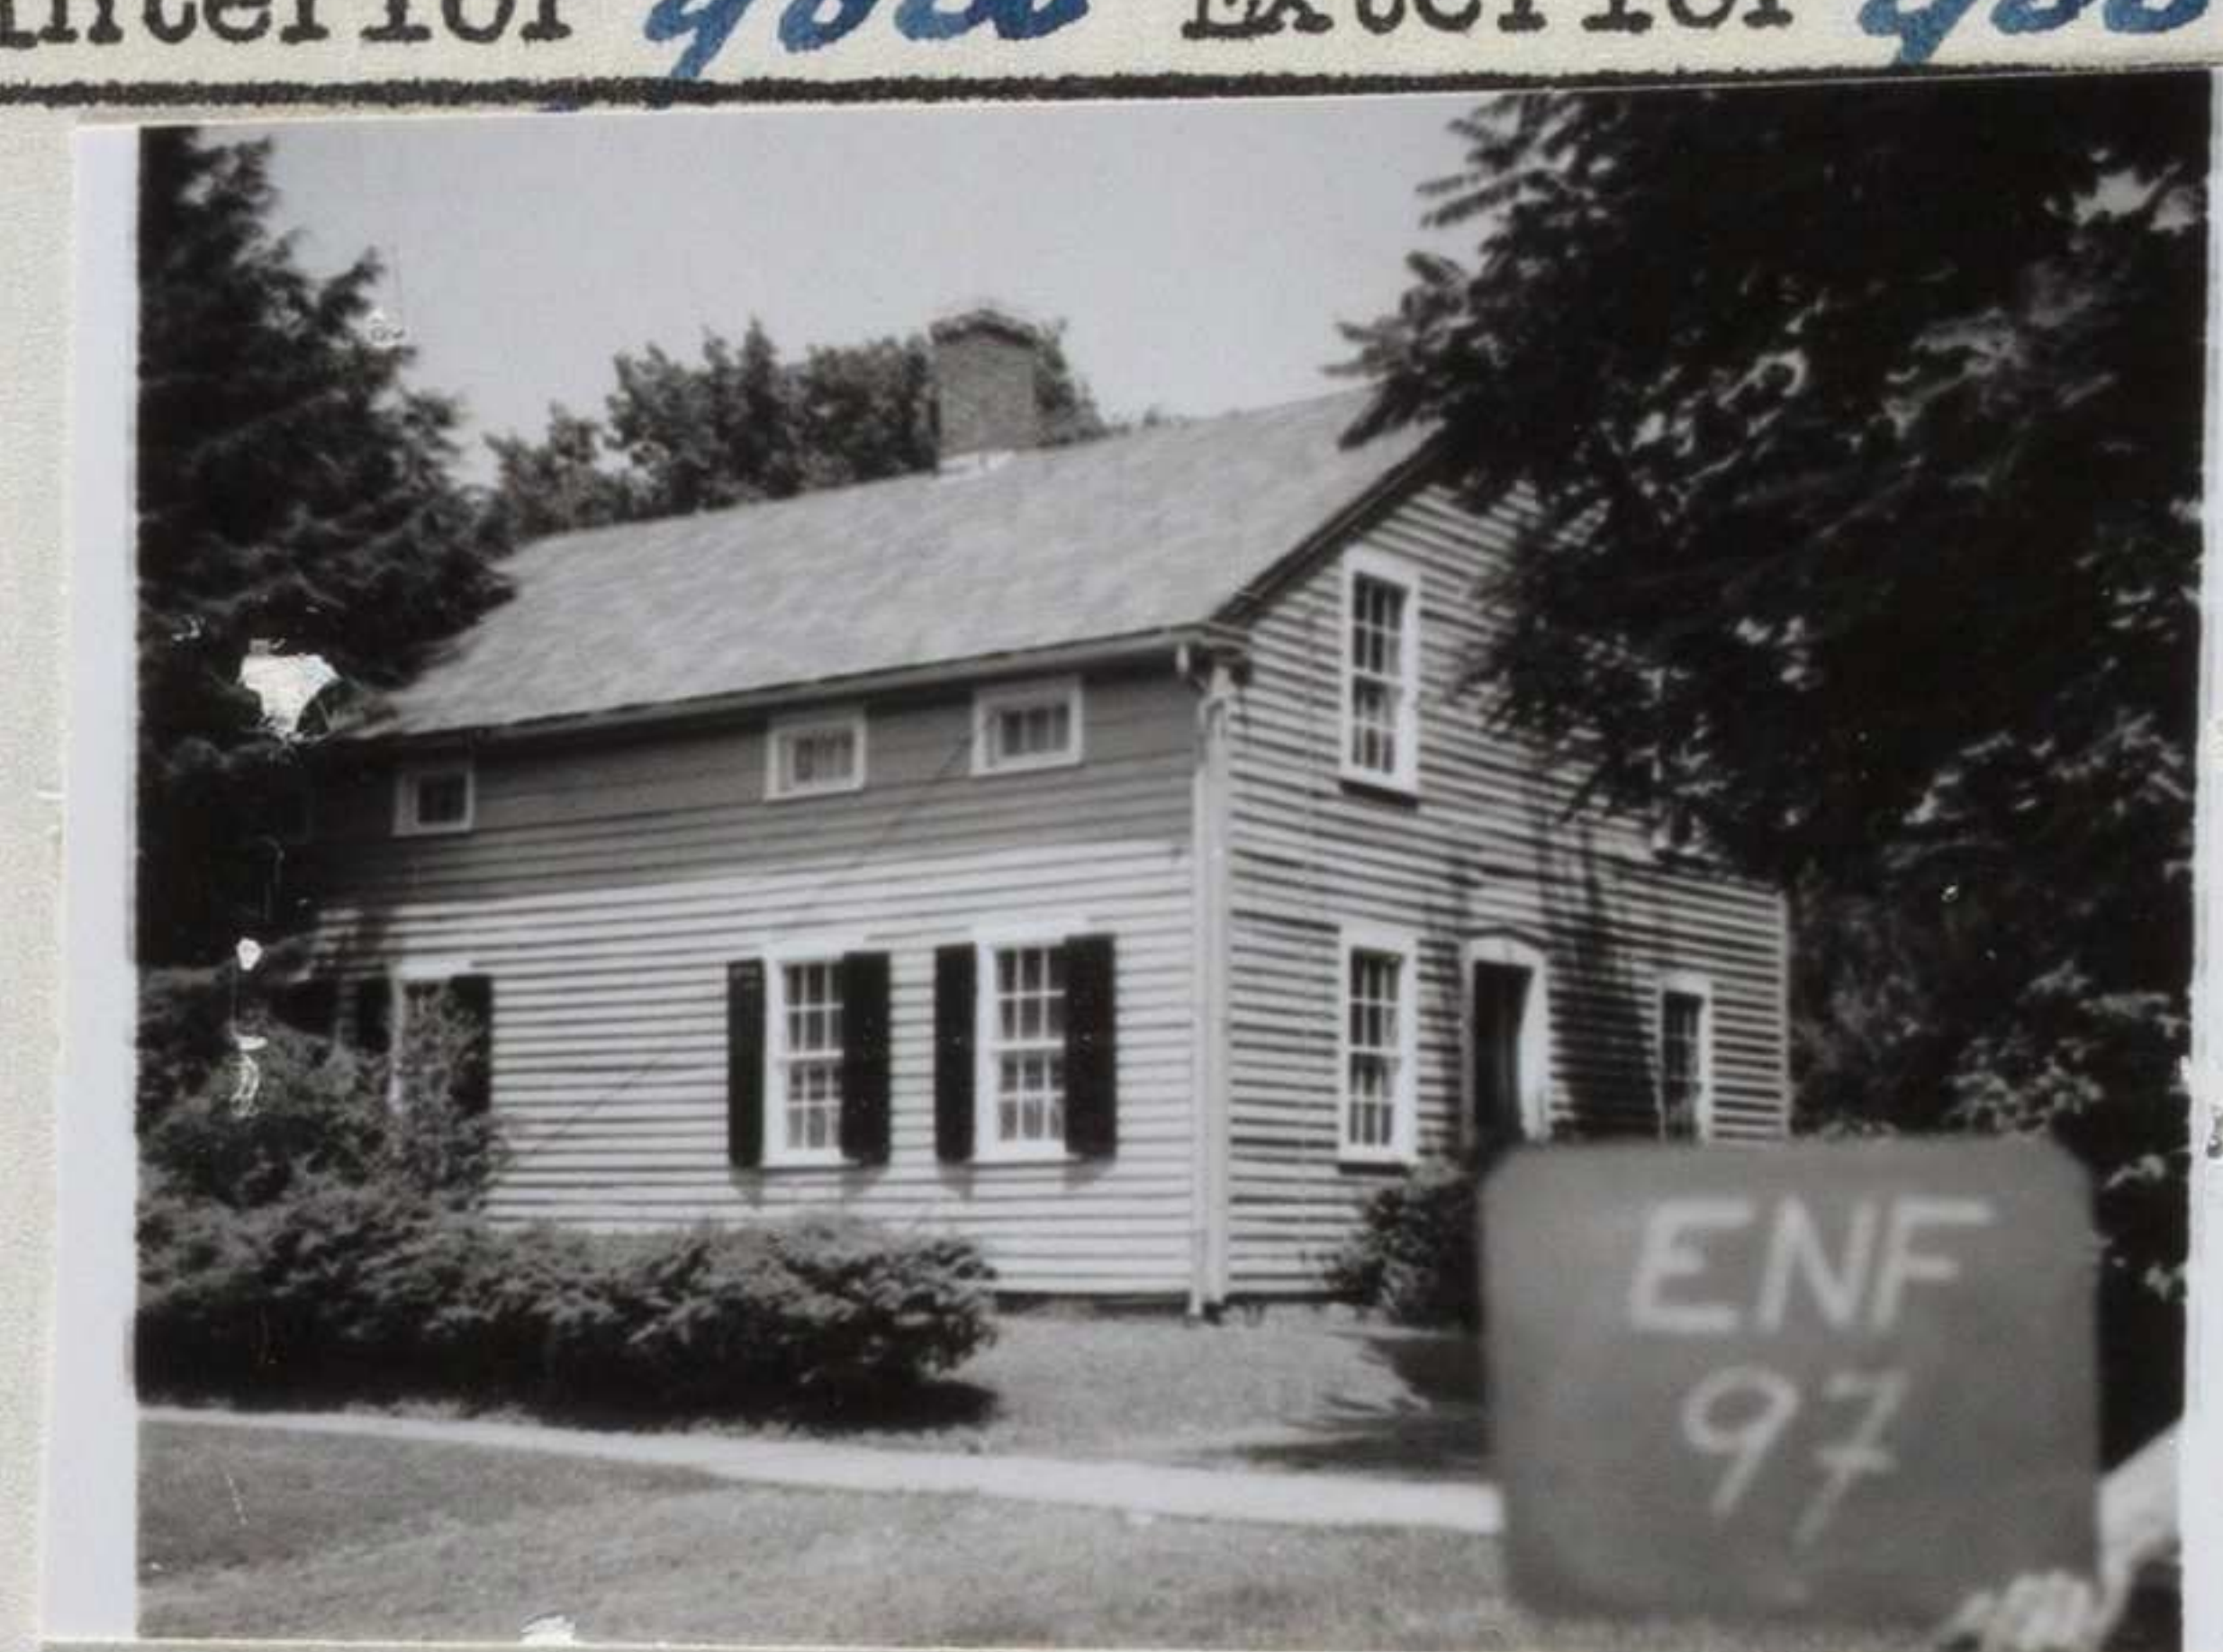
<p>7. PHOTOGRAPH <i>Enf 97</i></p>

<p>1. STATE <i>CT</i> COUNTY <i>Hartford</i> TOWN <i>Enfield</i> VICINITY STREET NO. <i>South Street #2</i></p> <p>ORIGINAL OWNER? ORIGINAL USE <i>Residence</i> PRESENT OWNER? PRESENT USE <i>Residence</i> WALL CONSTRUCTION <i>clapboard</i> NO. OF STORIES <i>1 1/2</i></p>		<p>HISTORIC AMERICAN BUILDINGS SURVEY INVENTORY</p> <p>2. NAME</p> <p>DATE OR PERIOD <i>1840?</i> STYLE <i>Greek Revival</i> ARCHITECT BUILDER</p> <p>3. FOR LIBRARY OF CONGRESS USE</p>		
<p>4. NOTABLE FEATURES, HISTORICAL SIGNIFICANCE AND DESCRIPTION</p> <p><i>This 1 1/2 story house is built on a brick foundation. There ^{are} 4 of a probable 5 bay facade remaining. The third bay is missing. The chimney crowns the center of a medium-pitched roof. The windows are 6/6 with half windows placed in the wide plain entablature.</i></p>		<p>OPEN TO PUBLIC <i>No</i></p>		
<p>5. PHYSICAL CONDITION OF STRUCTURE</p> <p><i>Endangered No Interior good Exterior good</i></p>		<p>6. LOCATION MAP (Plan Optional)</p>

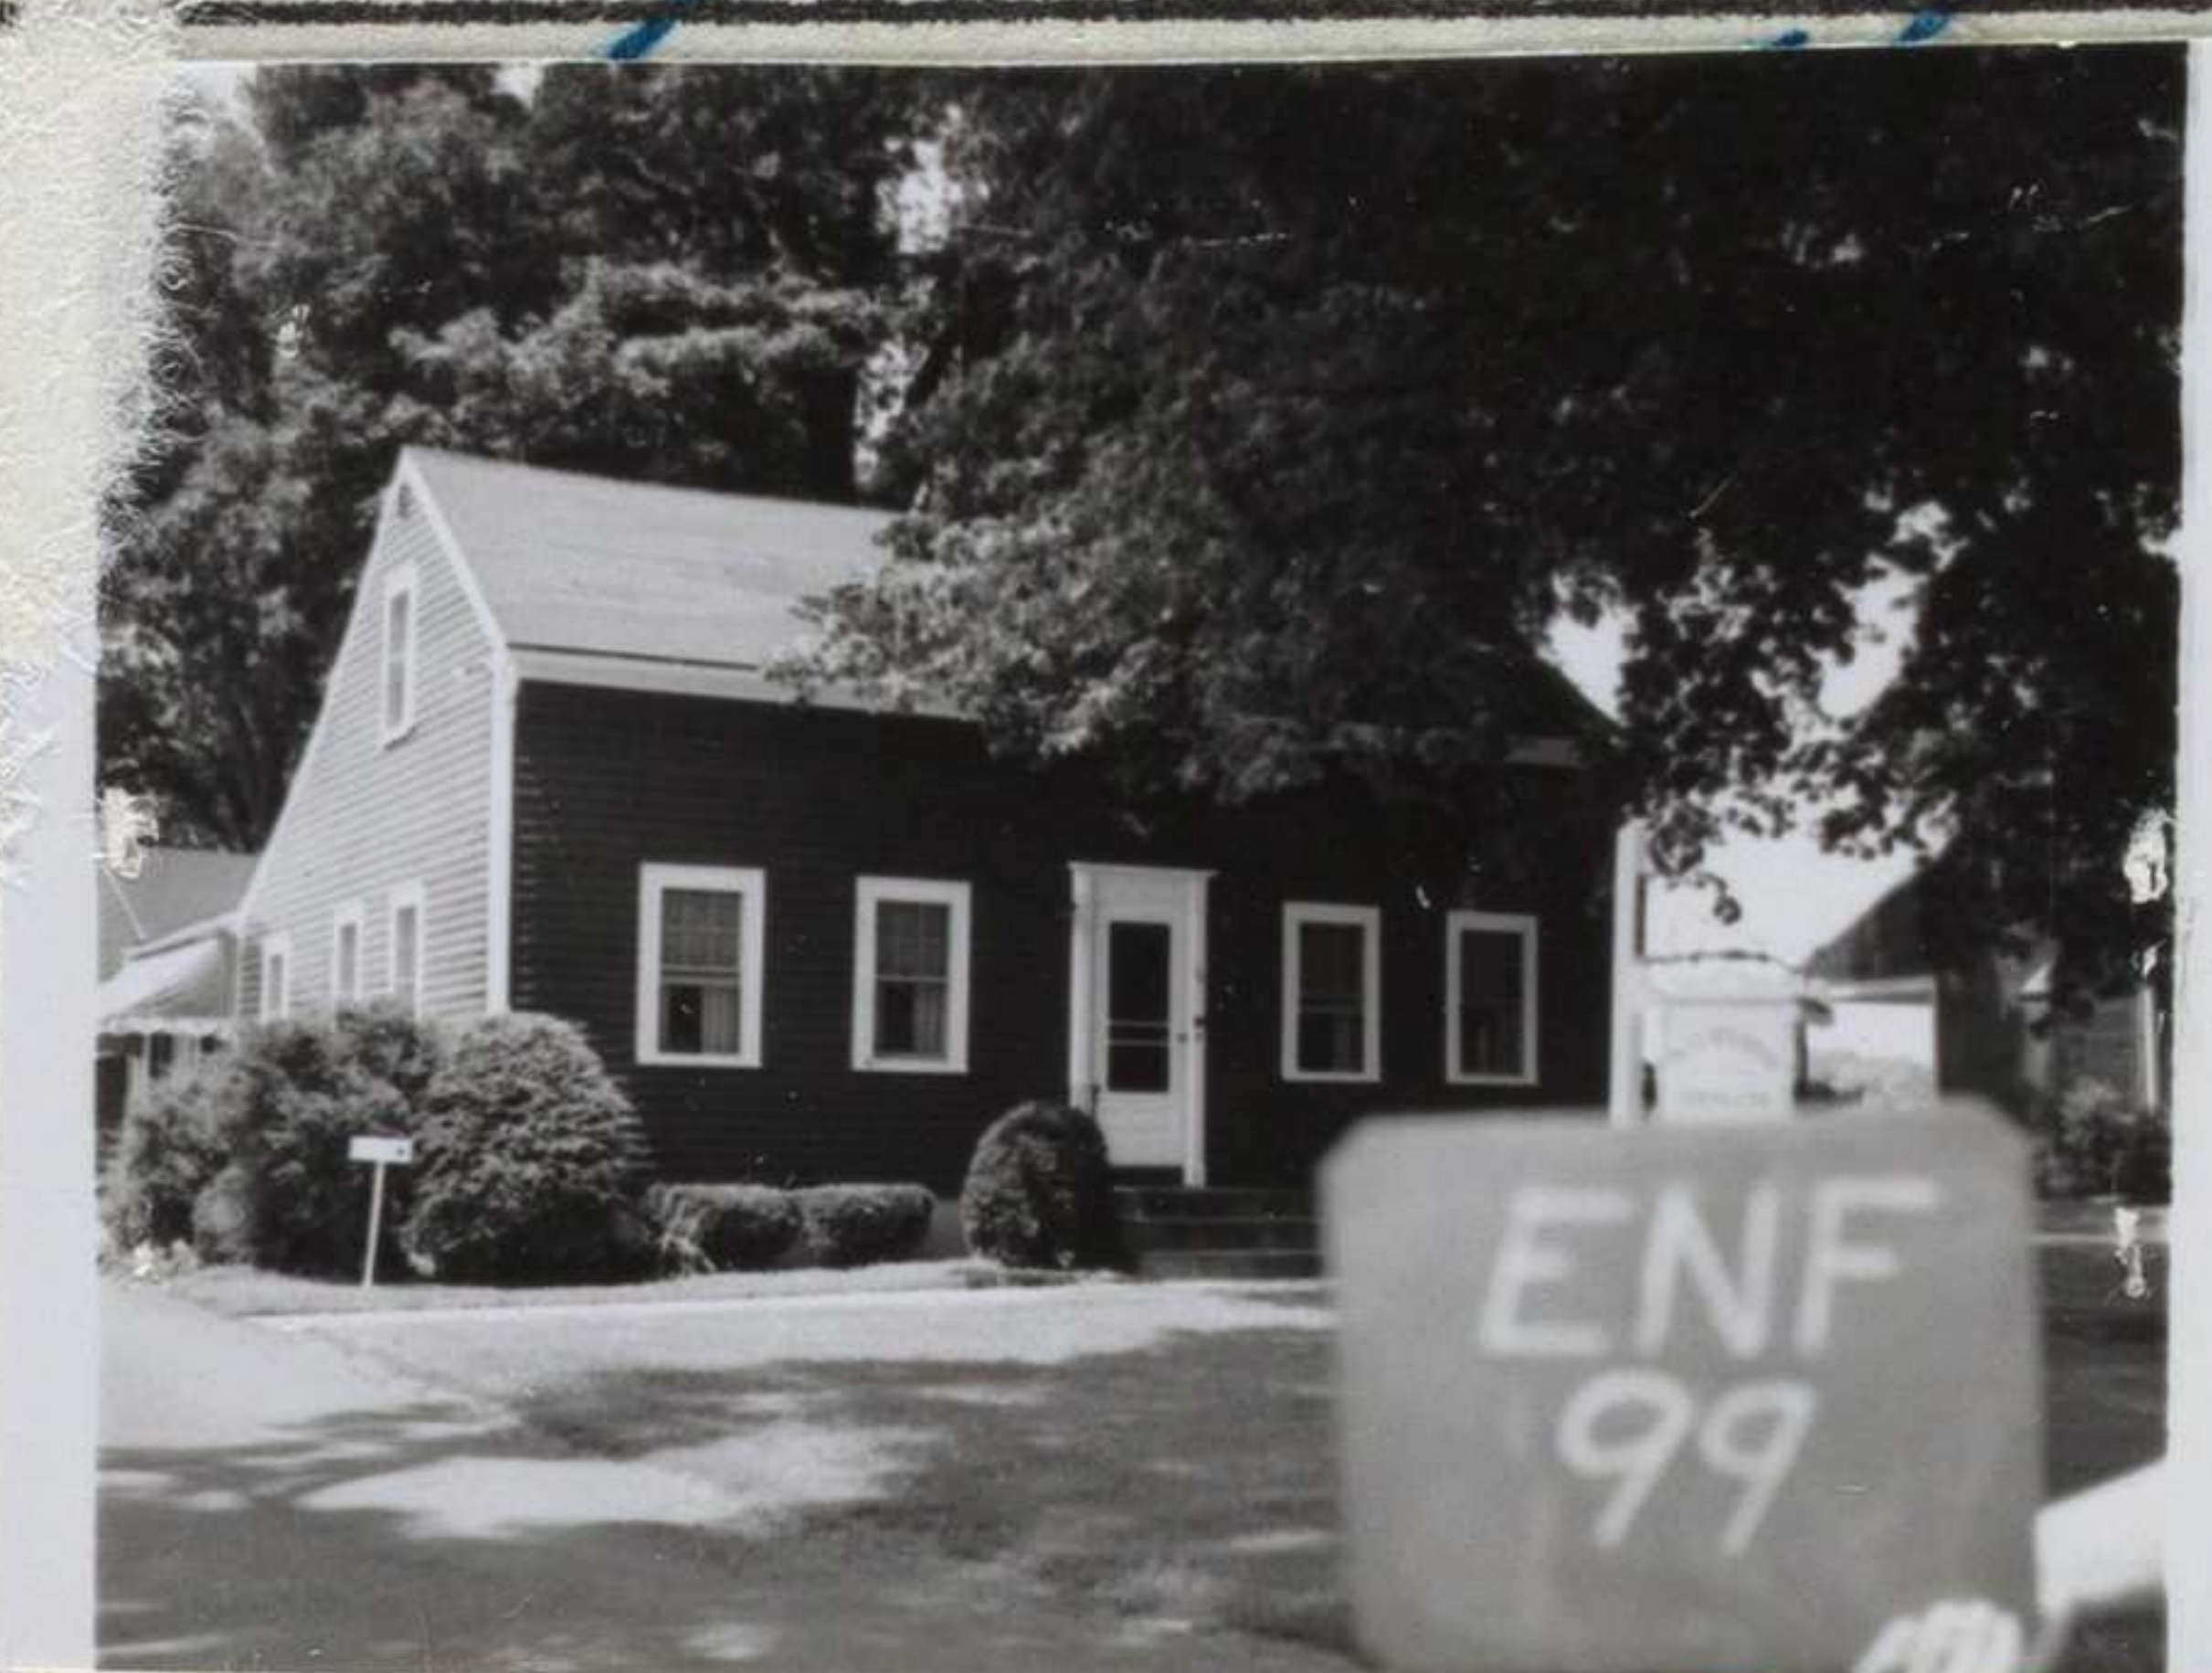
<p>7. PHOTOGRAPH <i>Enf 91</i></p>

<p>1. STATE <i>Ct</i> COUNTY <i>Hartford</i> TOWN <i>Enfield</i> VICINITY STREET NO. <i>corner Maple + Shaker</i></p> <p>ORIGINAL OWNER <i>Armstrong?</i> ORIGINAL USE <i>Residence</i> PRESENT OWNER <i>Richardson</i> PRESENT USE <i>Richardson Residence</i> WALL CONSTRUCTION <i>Clapboard</i> NO. OF STORIES <i>1</i></p>		<p>HISTORIC AMERICAN BUILDINGS SURVEY INVENTORY</p> <p>2. NAME <i>Armstrong House?</i> DATE OR PERIOD <i>1780?</i> STYLE <i>Colonial</i> ARCHITECT BUILDER</p> <p>3. FOR LIBRARY OF CONGRESS USE</p>		
<p>4. NOTABLE FEATURES, HISTORICAL SIGNIFICANCE AND DESCRIPTION</p> <p><i>This single story saltbox has five bays. There is a medium pitch to this roof. The house is built on brownstone foundation. Extensive renovations have made it difficult to determine other features' age.</i></p>		<p>OPEN TO PUBLIC <i>No</i></p>		
<p>5. PHYSICAL CONDITION OF STRUCTURE</p> <p><i>Endangered No Interior poor Exterior good</i></p>		<p>6. LOCATION MAP (Plan Optional)</p>
